# NILIM has constructed a new full-scale experimental facility

September 8<sup>th</sup>, 2020

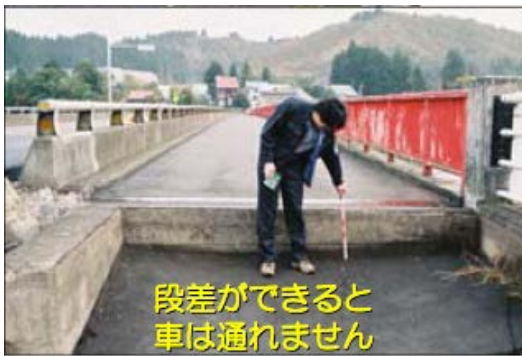
**Fig.1 A step in approach section of the bridge**

After earthquakes and other disasters, road steps may occur at the connections between embankment and bridges. (Fig.1)

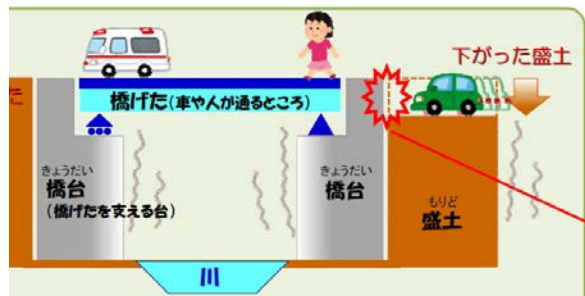
**Fig.2 A step after an earthquake**

This is because the settlement depth of the road base differs depending on the stiffness of the base materials. (Fig.2)

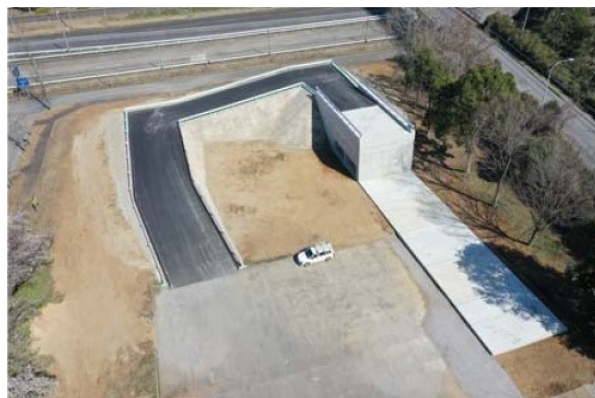
**Fig.3 The appearance of the facility**

For evaluating the technology to solve these problems, NILIM has constructed a new full-scale experimental facility (Fig.3). This facility is a reinforced concrete structure with a box culvert and a 1-meter thick concrete slab.

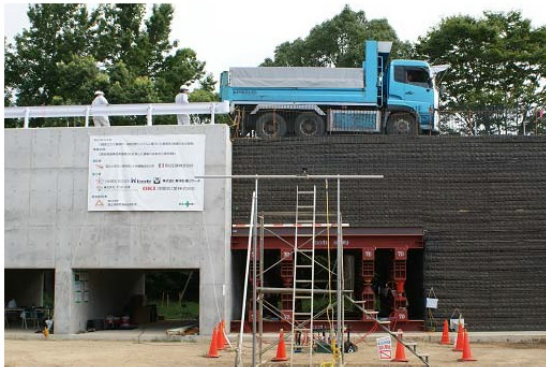
**Fig.4 The embankment is formed on the facility**

An example of experimental process is following; first, embankment and pavement are constructed on jacks placed on the concrete slab. Next, the step is generated, by causing forced displacement on the embankment.

August and September 2020, NILIM conducted a joint experiment with Gifu University. In this experiment, a new pavement reinforcement technique developed by Gifu University was evaluated. (Fig.4 Fig.5)

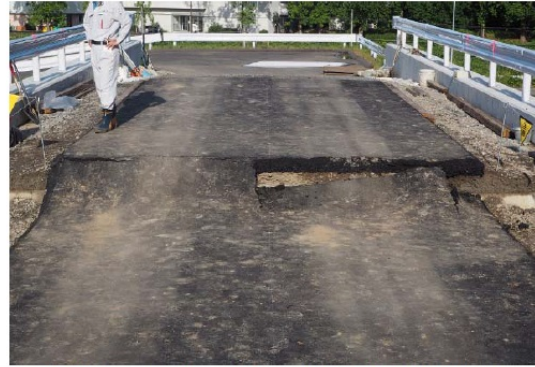
**Fig.5 The step after experiment (There are reinforcing materials on the left side.)**
